Manhole Inspection Summary

Manhole # S43KK_034MH

Location Address: **1720 BROADWAY ST**

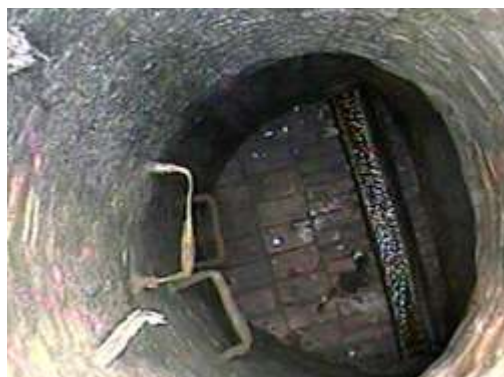
Defect 1

Steps Count: **5** Missing: **2** ☒ **Corroded**

STEPS CORRODED

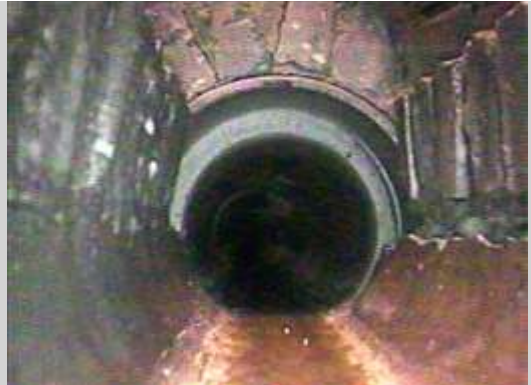
12 O'Clock Outflow

8 in. Circular Gravity Sewer
Pipe Out @ 12 O'Clock

Pipe Height: (in.) Direct
Pipe Material: **Clay** ☐ Pipe Lined
Invert Depth: **8.93** (ft.) Flow Characteristics: **Fast**
Deposits: ☒ None ☐ Mud ☐ Sludge ☐ Debris ☐ Grease
Silt Depth: (in.) Deposits Extent:
Infiltration: **None** Pipe Seal Cond: **Sound**

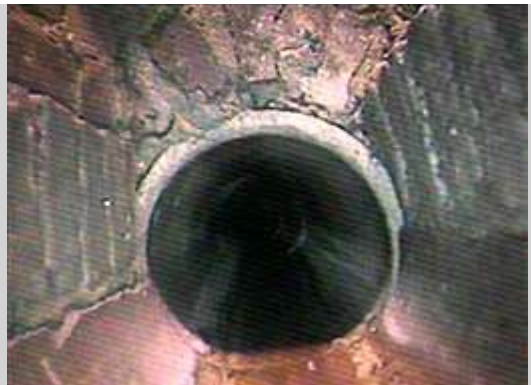
6 O'Clock Inflow

8 in. Circular Gravity Sewer
Pipe In @ 6 O'Clock

Pipe Height: (in.) Direct
Pipe Material: **Clay** ☐ Pipe Lined
Invert Depth: **8.94** (ft.) Flow Characteristics: **Fast**
Deposits: ☒ None ☐ Mud ☐ Sludge ☐ Debris ☐ Grease
Silt Depth: (in.) Deposits Extent:
Infiltration: **None** Pipe Seal Cond: **Sound**
